May 18, 2018

## Summary of Findings: Upper Onion Creek Dye Trace, Hays County, Texas, Winter 2017

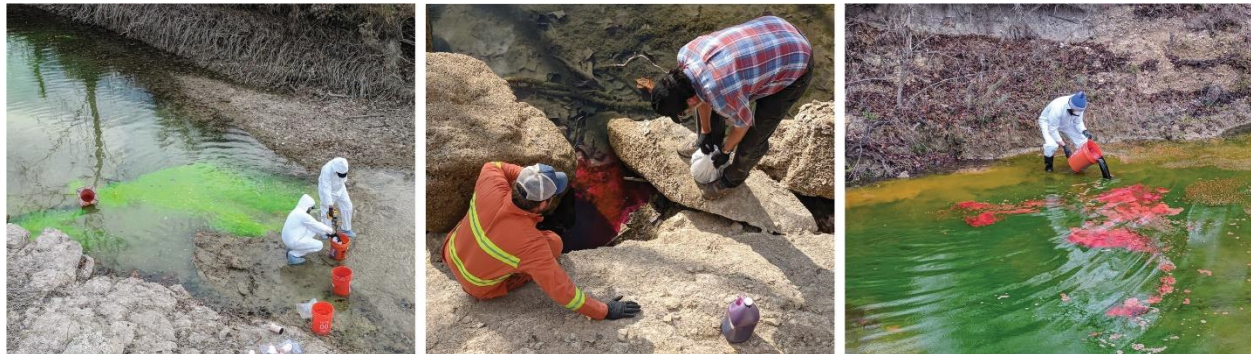
**Figure 3-**Dye injection photos: (left) Howard Ranch Swallet; (middle) Bigote Swallet; (right) South Onion Creek at Gatlin Creek Rd. crossing.

For the Howard Ranch and Bigote Swallet injections, dye was introduced directly into recharging karst features (swallets) in the bed of Onion Creek (Figure 3). Dye from the Howard Ranch Swallet injection was carried into the subsurface by flow from Onion Creek. Dye from the Bigote Swallet injection was carried into the subsurface by flow from a nearby spring. The South Onion Creek injection was carried out by introducing dye into a pool of surface water. The dye was then carried downstream by creek flow across a known losing (recharging) reach although specific swallets are not currently known.

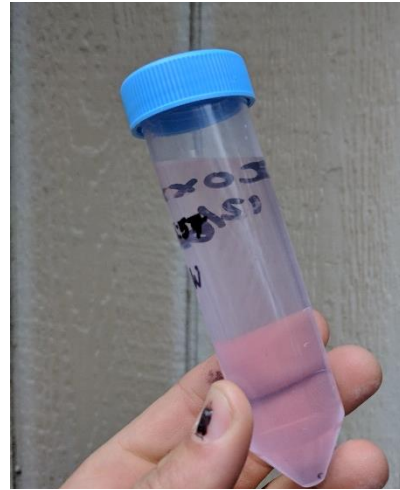
**Figure 6**-Sample of well water with visible RWT.

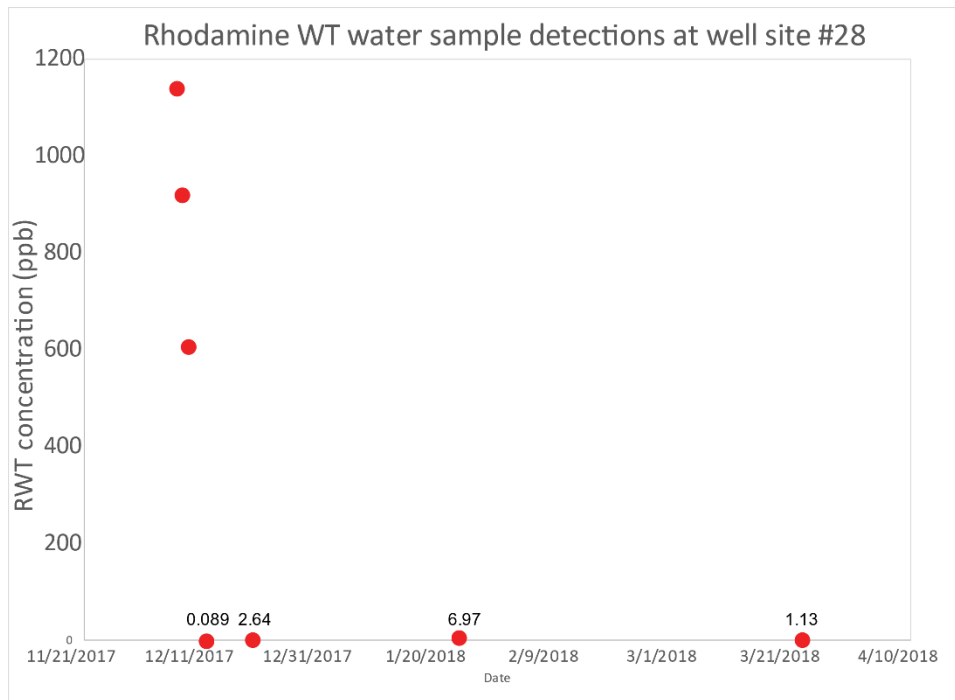
**Figure 7**-Water sample RWT concentrations from well ID #28.
